Replacement of Transformers on Middelgrunden Offshore Wind Farm

Jens Larsen, jens.larsen@grontmij-carlbro.dk,
 Rajinder Singh Sagoo, rajinder.sagoo@grontmij-carlbro.dk
 Grontmij | Carl Bro, Phone +45 4348 4622

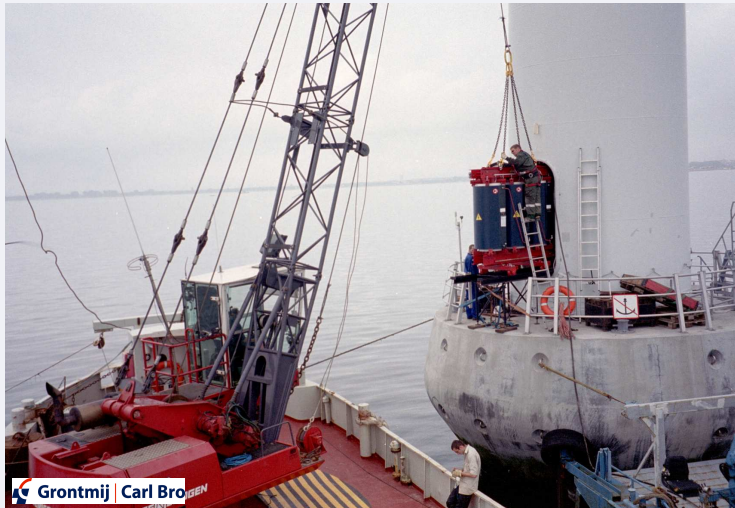
Fig. 1 Installation of transformer by working vessels. The space is very limited in the tower and there is only 1 cm of free space along the transformer during the installation process.

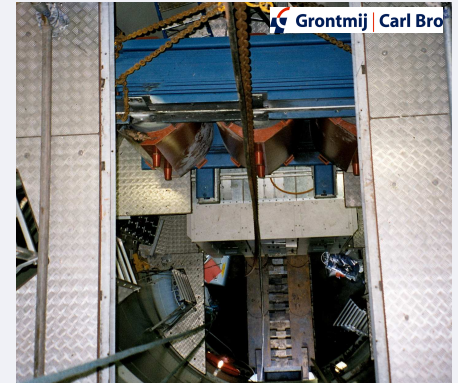
Fig. 3 Looking down at the transformer after dismantle of 3. floors inside the tower.

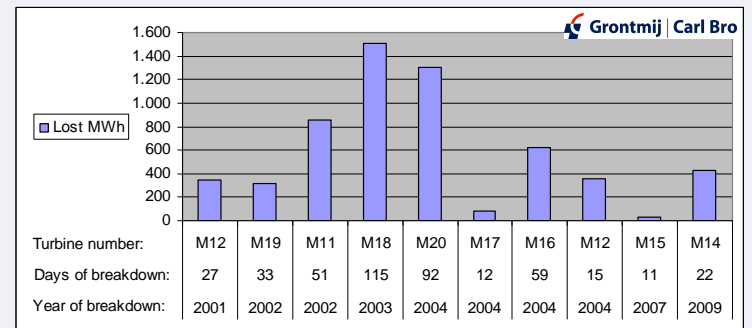
The optimal working period is achieved to be 11 working days, see figure 4. The cost of exchanging one transformer is stated in figure 5. This figures includes the cost of the transformer together with the production loss during the exchange process. The production loss has a big variation depending on the downtime of the turbine and wind energy in the exchange period, see figure 4. The maximum downtime in 2003 was 115 days. This was due to the discussions with the manufacturer and the lack of available transformers.

Fig. 4 Lost production after transformer breakdown. Days of breakdown before new transformer was installed, turbine number and year of breakdown is stated beneath the figure.
